### The Road Safety Audit Experience

Aaron Johnson – MDOT Superior Region - Ishpeming TSC

### Two Example RSAs

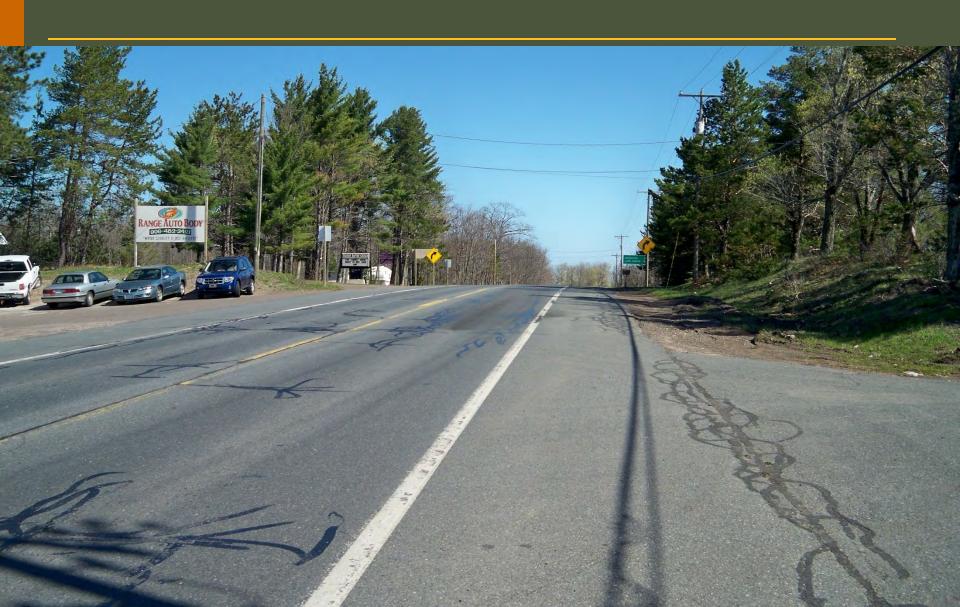
### Curve Visibility - NB

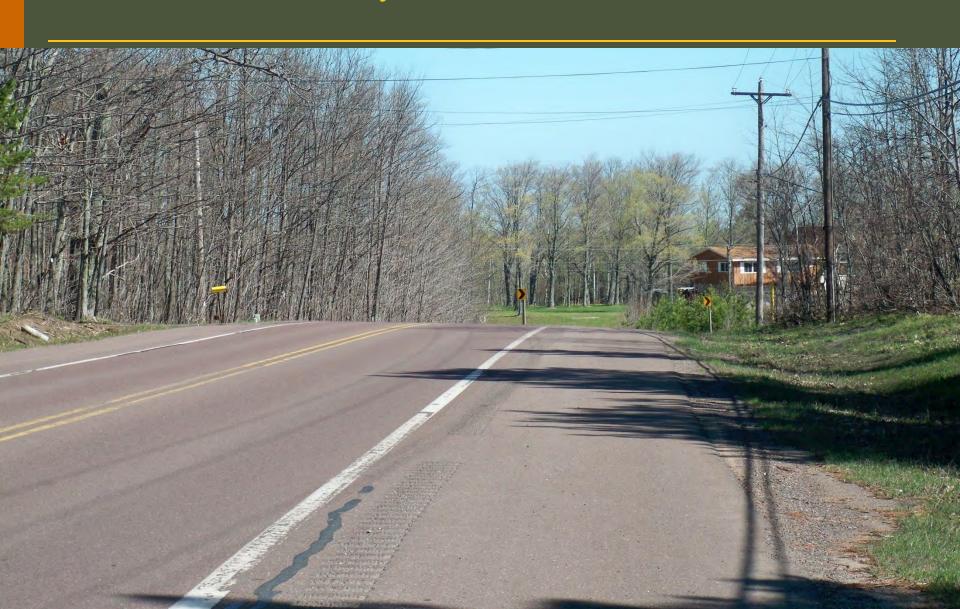
## Curve Visibility

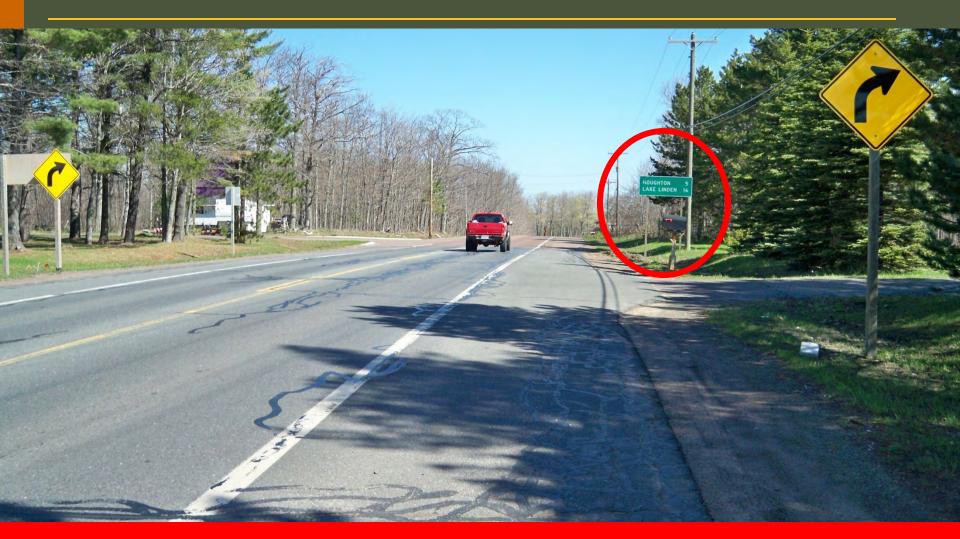
### Signing

Destination Sign - NB

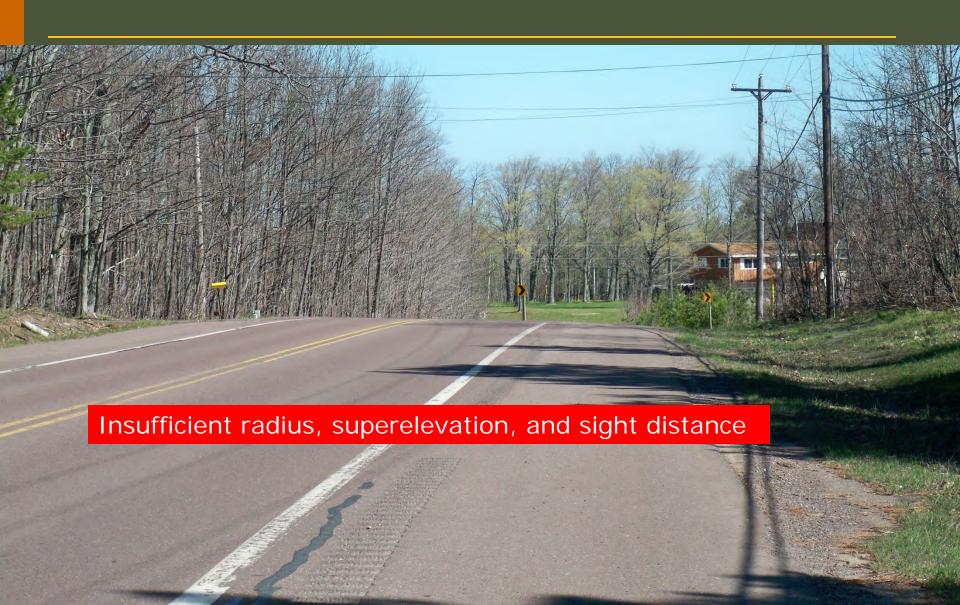
### Geometrics of the Curve

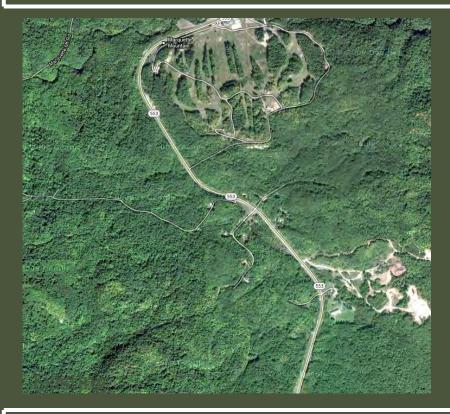
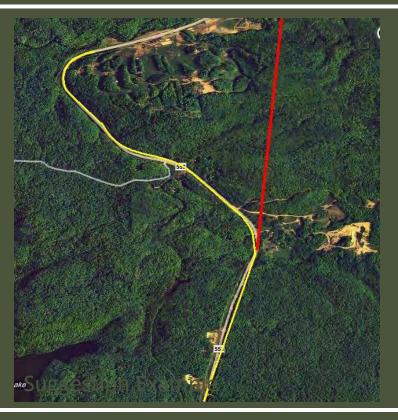
EXPECTED FREQUENCY	EXPECTED SEVERITY	RISK RATING	_
Occasional	High	High	E

SUGGESTION: Improve horizontal and vertical curve geometrics to meet 60 MPH design speed, (50 MPH currently). Includes superelevation improvements.

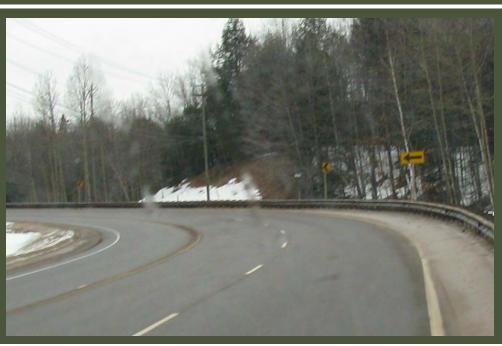
EXPECTED FREQUENCY	EXPECTED SEVERITY	RISK RATING	_				
Occasional	High	High	E				
ODCEDVATION D:

SUGGESTION: Increase sign sizes and reduce sign location offset. Upgrade sign sheeting. Upgrade signs to meet current MMUTCD. Add reflective sheeting to sign posts. Add chevrons and target arrows to all curve sections. Add advisory speeds to advance curve warning signs. Add object marker signs to end of guardrail sections.

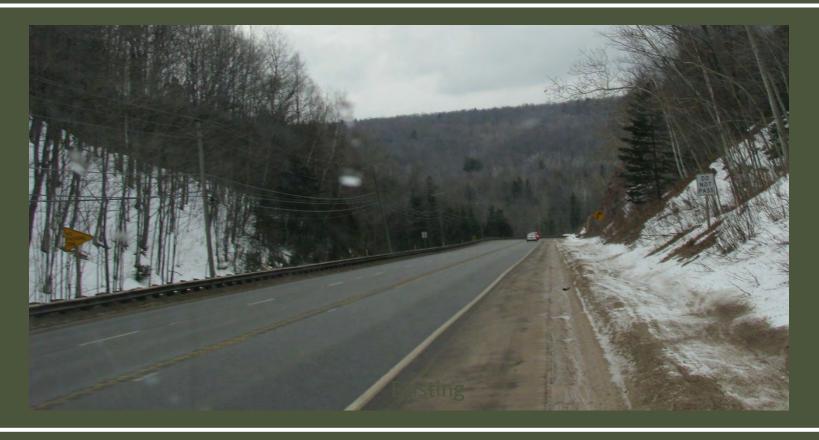
EXPECTED FREQUENCY	EXPECTED SEVERITY	RISK RATING	_
Occasional	High	High	E

SUGGESTION: Remove and consolidate the passing zones. Remove all corresponding signs and repaint pavement markings to reflect the change.

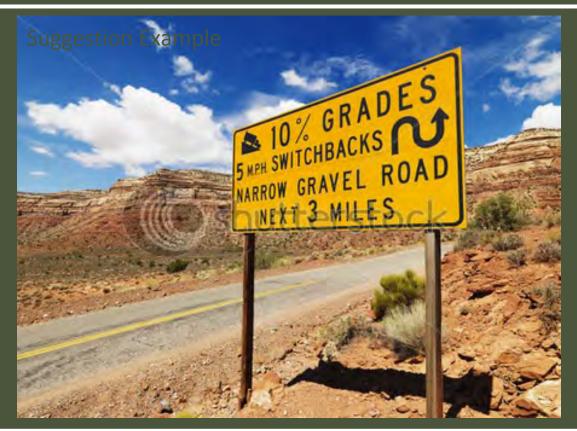
EXPECTED FREQUENCY	EXPECTED SEVERITY	RISK RATING	_
Occasional	High	High

SUGGESTION: Place a special detail sign at the beginning of the segment in each direction to indicate hill terrain and curves ahead.

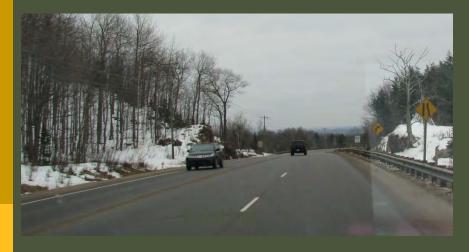
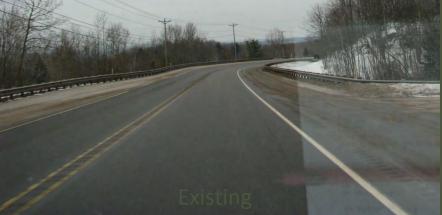
EXPECTED FREQUENCY	EXPECTED SEVERITY	RISK RATING	_
Occasional	High	High	E .

OBSERVATION: Crashes are occurring at the end of the taper section in the horizontal curve, (near the driveways to the north).

SUGGESTION: Short Term - Update taper warning signs to reflect MMUTCD. Long Term - Extend the truck climbing lane to the tangent portion of M-553, (~3500' further).

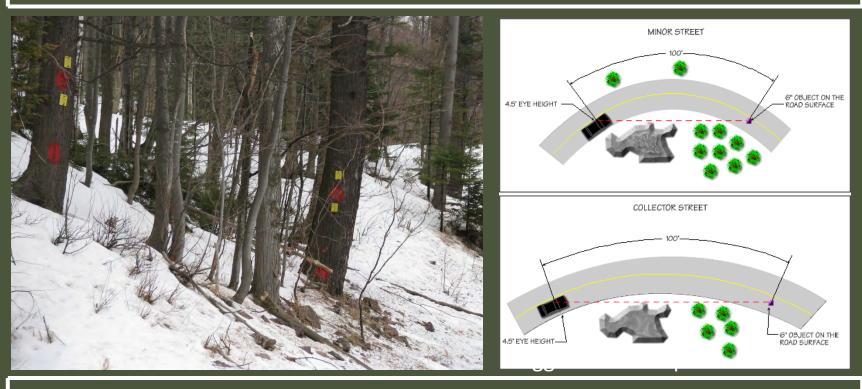
Occasional	Medium	Moderate	D
EXPECTED FREQUENCY	EXPECTED SEVERITY	RISK RATING

OBSERVATION: Northern curve near Marquette Mtn. is limited to any geometric realignment.

SUGGESTION: Add a high friction surface to roadway. Clear trees and other fixed objects in clear zone. Cut down and move the backslopes further from the roadway.

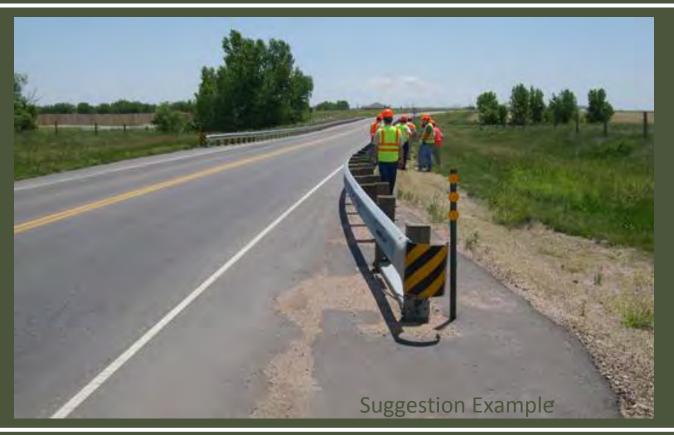
EXPECTED FREQUENCY	EXPECTED SEVERITY	RISK RATING	_
Rare	High	Moderate	ע

OBSERVATION: Possible foreslopes may requiring shielding.

SUGGESTION: Extend guardrail to shield foreslopes. Extend approach terminal.

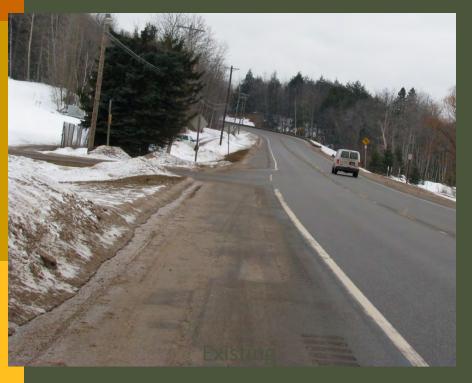
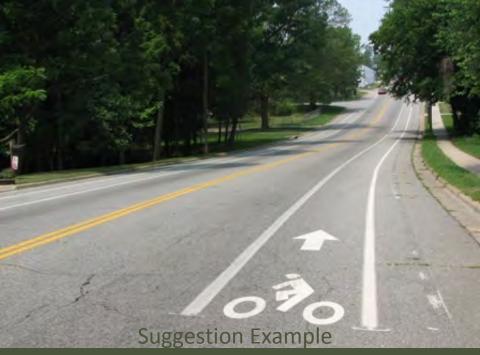
EXPECTED FREQUENCY	EXPECTED SEVERITY	RISK RATING	<b>D</b>
Rare	High	High	D

OBSERVATION: Potential bicycle conflicts.

SUGGESTION: Increase shoulder width to uniform standard. Add rumble strips in shoulder where missing. Potentially add bicycle share the road signs.

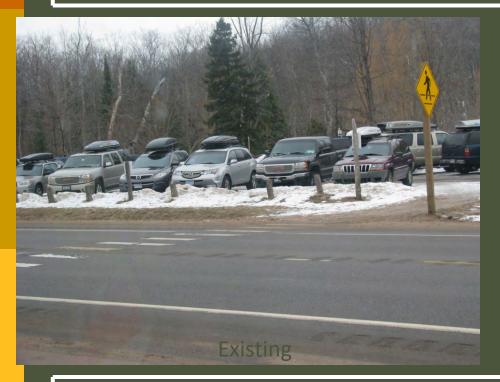
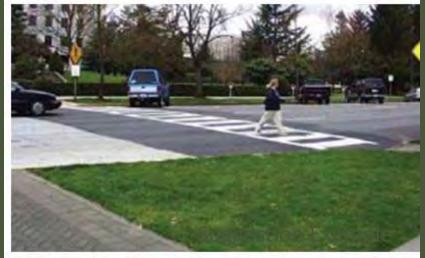
EXPECTED FREQUENCY	EXPECTED SEVERITY	RISK RATING	
Rare	Medium	Low

OBSERVATION: Pedestrian conflicts near Marquette Mtn. at the pedestrian roadway crossing.

SUGGESTION: Update pedestrian crossing sequence; Including high visibility pedestrian pavement markings, pedestrian signing upgrades, and adding diagonal target arrows at crossing.
